**CALTRANS ENGINEERING SERVICE CENTER
POST EARTHQUAKE INVESTIGATION TEAM REPORT**

**THE HECTOR MINE EARTHQUAKE
OF OCTOBER 16, 1999**

Post Earthquake Investigation Team Report

Performance of Bridges during the Hector Mine Earthquake **of October 16, 1999**

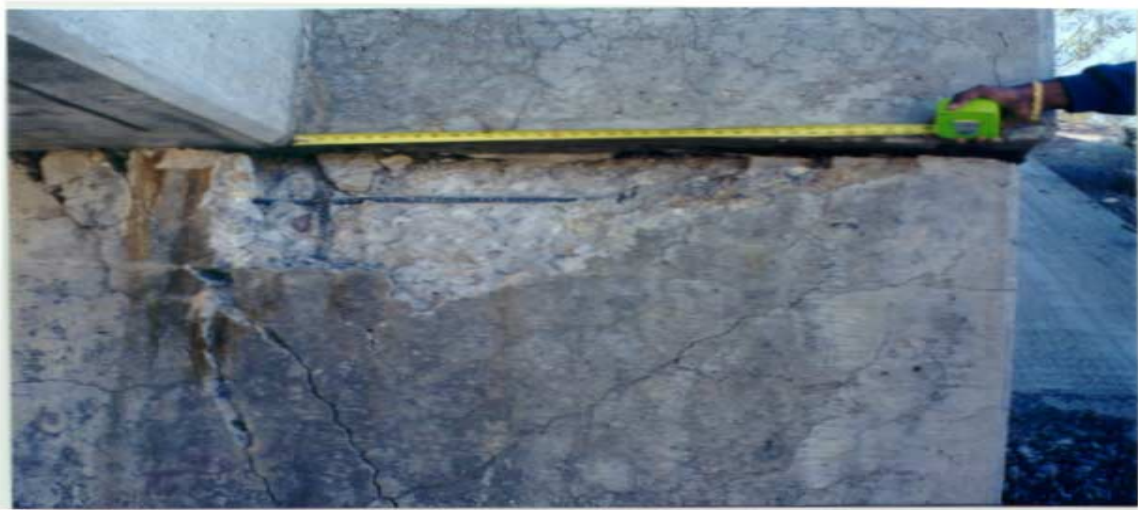
Figure 4.

It should be noted that this structure was most likely constructed with reactive aggregate. It is our opinion that most of the cracks at the time of earthquake had already developed due to ASR reactivity. The Hector Mine earthquake merely increased the crack width (See Figure 4, 9, and 12).

Spalling and damage at North abutment due to transverse movement.

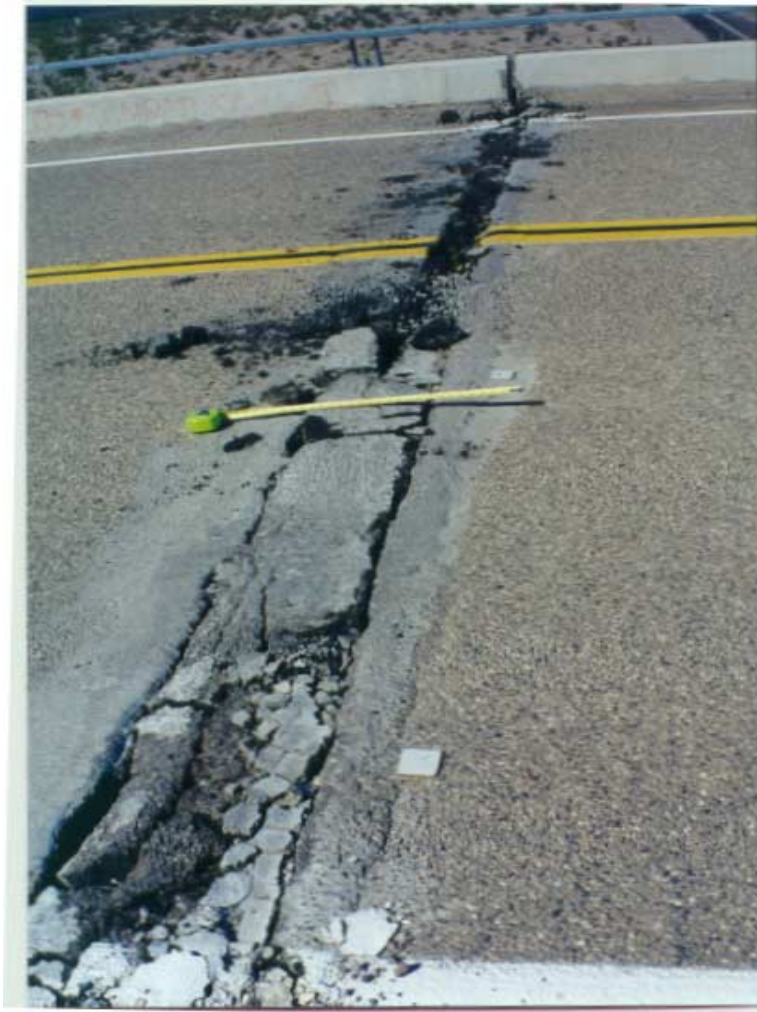
Figure 6. **54-0734** **Lavic Road OC**
 Damage at south abutment expansion joint due to longitudinal movement.

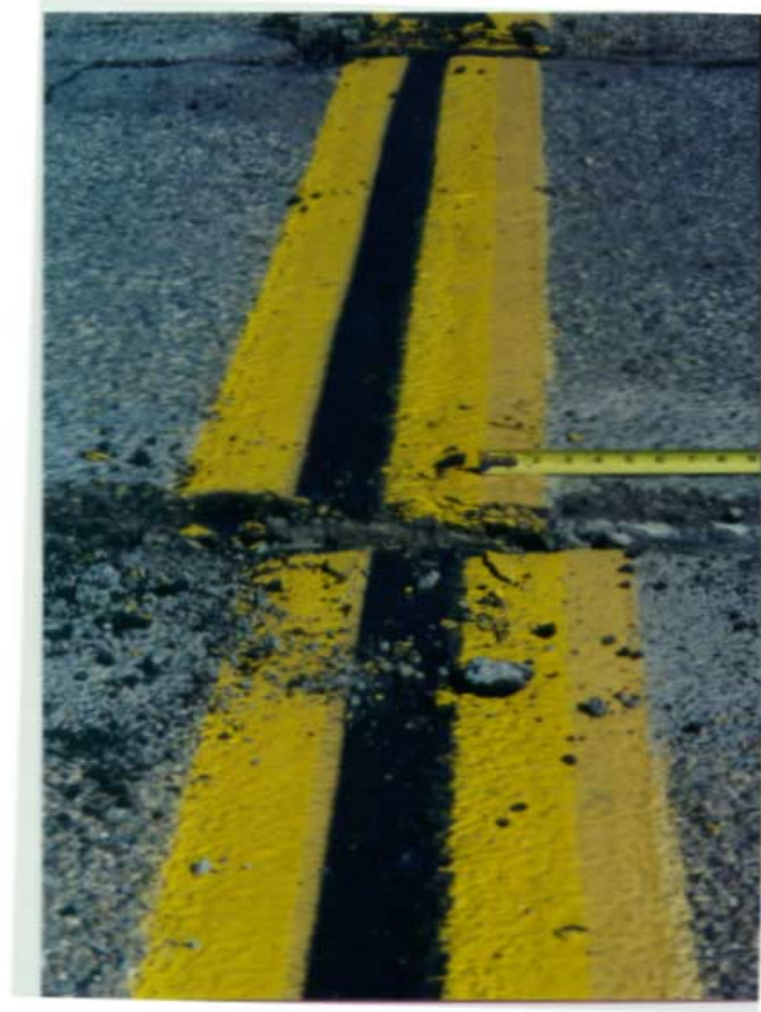
Lavic Road OC sustained moderate damage during the Hector Mine earthquake. The bridge is a two span reinforced concrete box girder with a single column bent (See General Plan, Figure 5). The damage was limited to the abutments. An inspection of visible sections of the column indicated no signs of cracking and/or distress. The bottom of the column was not inspected, as it is about seven to eight feet below the ground level. The structure experienced movements that resulted in the final displacements of 3" longitudinally, and about 2.5" to 3" in the transverse direction (Refer to Figure 7 and 8). The approach embankments settled approximately ½" to 2".

Figure 7. **54-0734** **Lavic Road OC**
 Three (3) inches transverse shift along the bridge center line at north abutment.

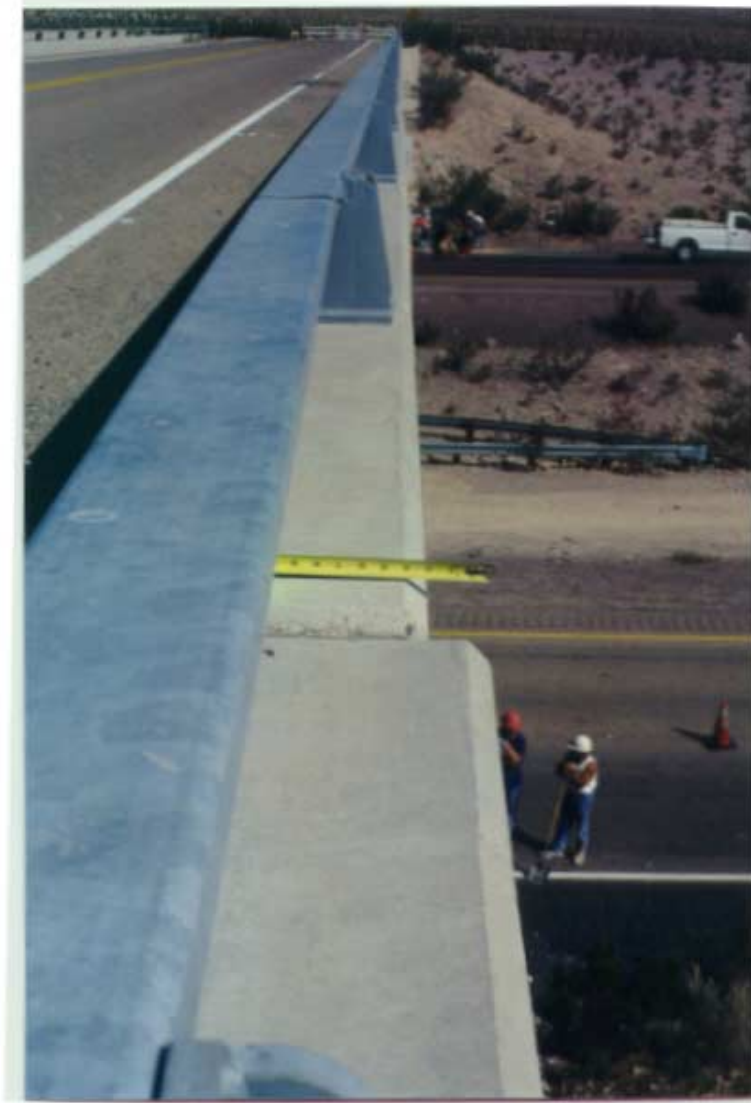
Figure 8. **54-0734** **Lavic Road OC**
Lateral displacement at south abutment.

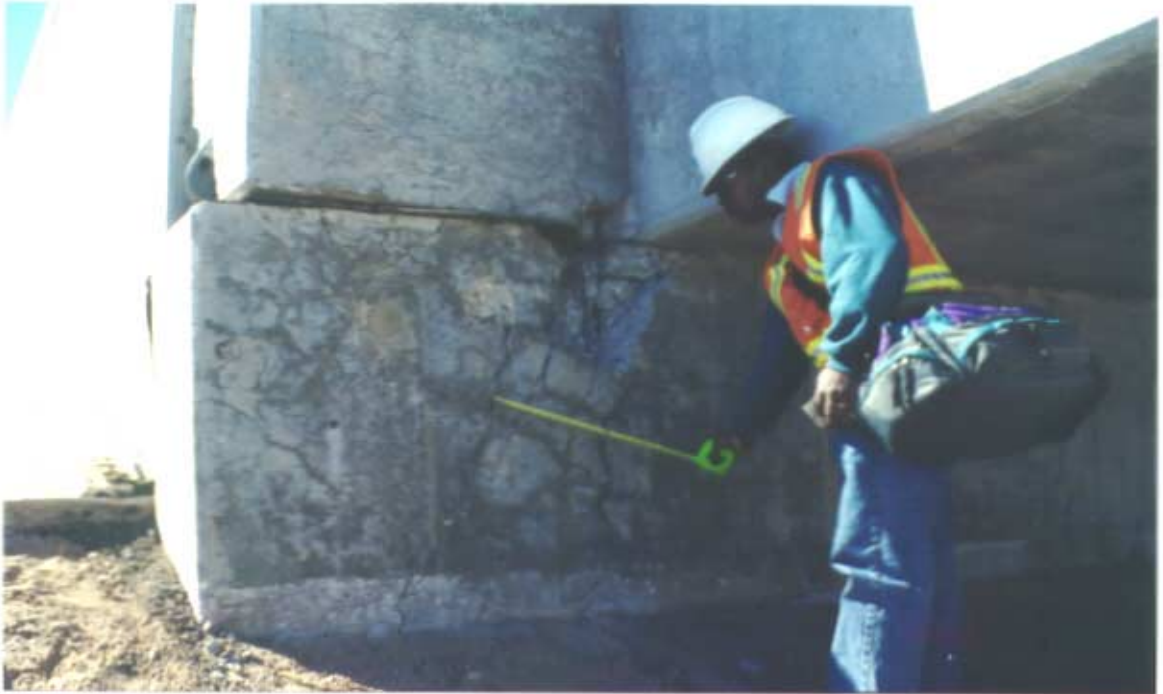
Figure 9.

Shear failure at north abutment.

The Lavic Road Overcrossing abutment cracking and spalling was in part the result of a long-standing problem with reactive aggregates that have slowly weakened the concrete. In fact, this bridge was being studied for repairs or possible replacement at the time of this earthquake (Refer to Figures 9, 12, and Appendix of this report).

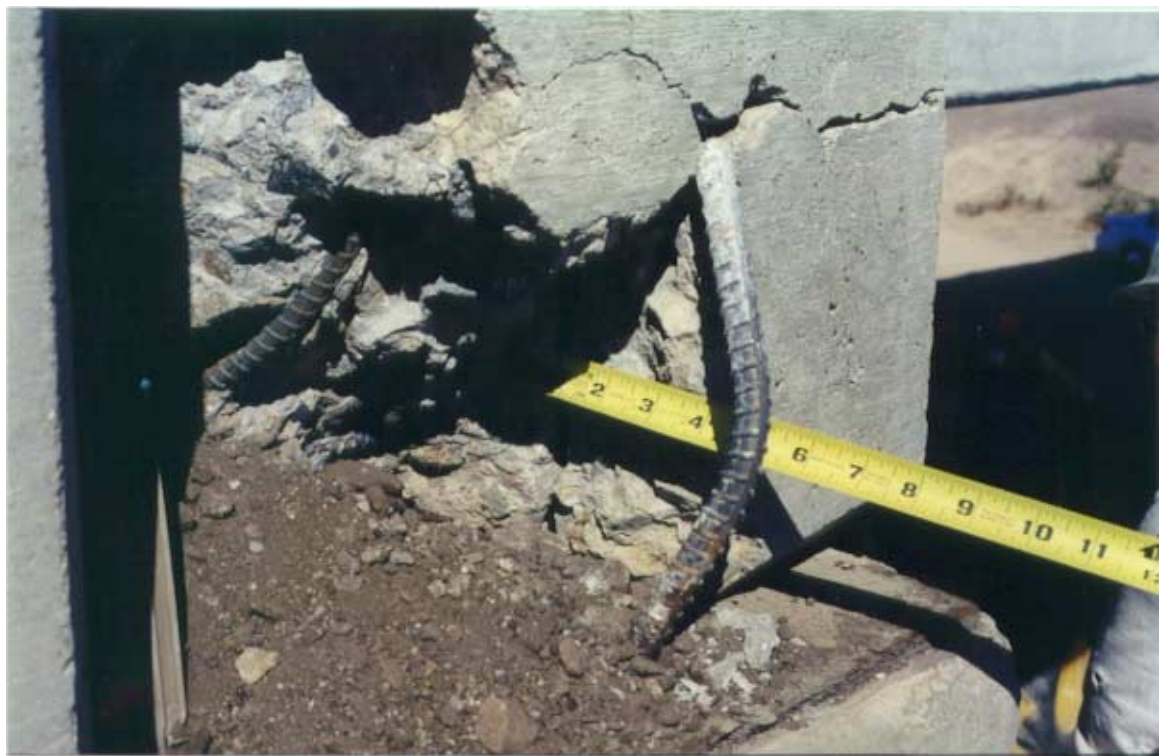
Figure 10.

Considerable shear damage at north abutment.

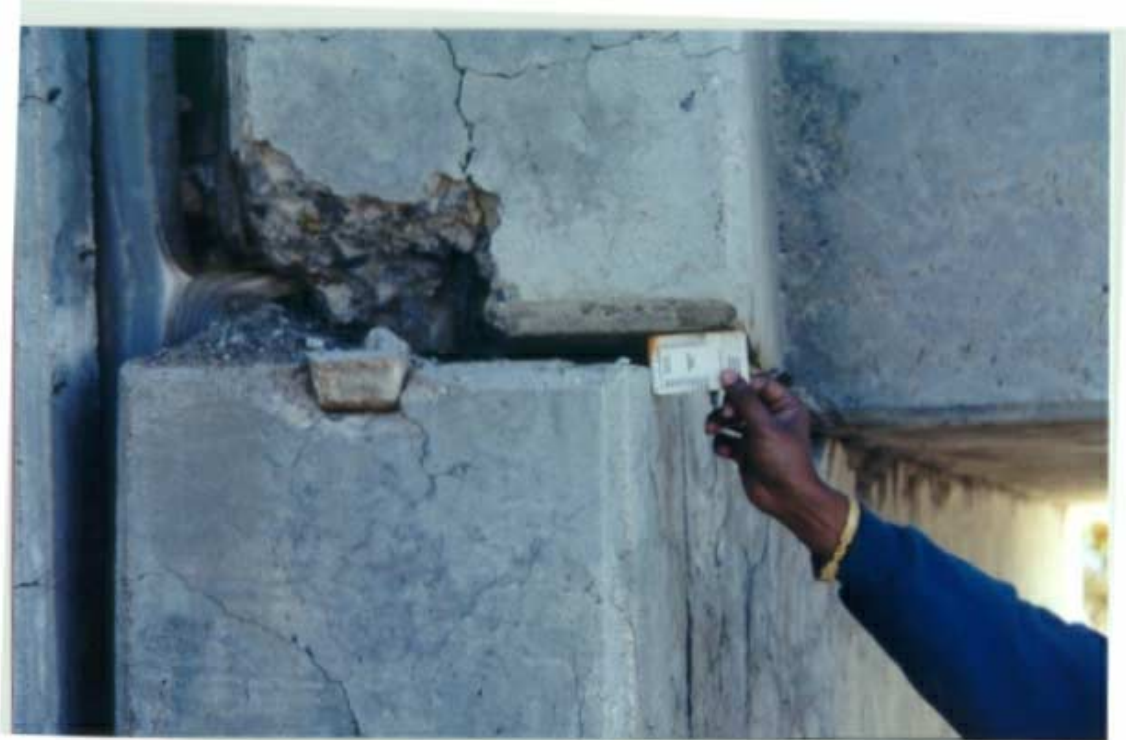
Figure 11.

Detail of the damage at south abutment.

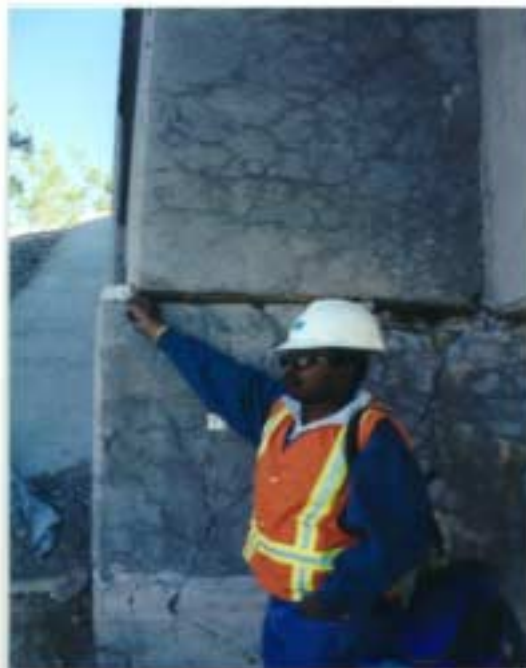
Figure 12.

3 1/2" transverse movement in the superstructure.

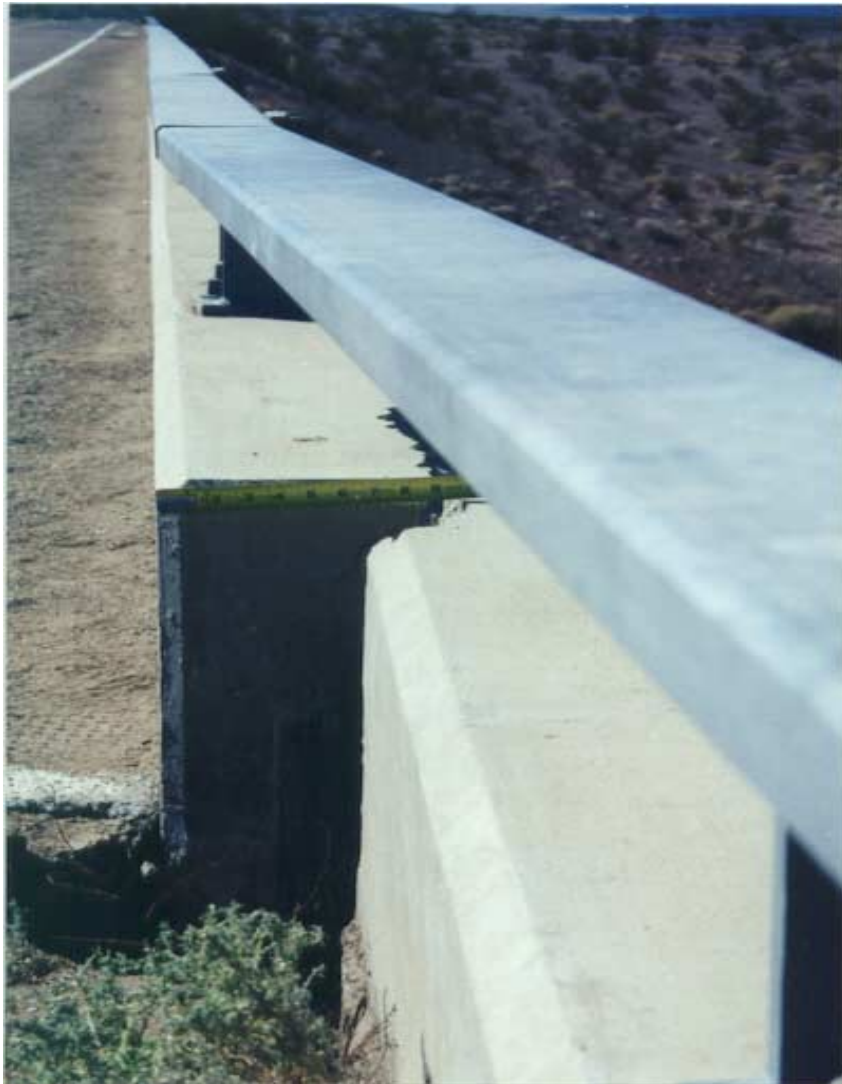
The integral diaphragm abutment details are inconsistent with current design practice. There are two pin connections, one at the superstructure - abutment wall transition, and the other at the abutment wall - footing connection. The wingwalls are independent and do not tie into the abutment walls. The transverse shear capacity of the abutments was limited to the strength of the dowels at the pin connections. As the abutments moved in the transverse direction, the shear resistance offered by the dowels was exceeded. This resulted in pullout of shear dowels at the edges of the end diaphragm walls (Figures 9 and 10), presumably shearing off the internal dowels. Shear cracks developed at the abutment walls (Figures 4, 9, and 12). The wingwalls rotated about their bases, resulting in a net shift up to 7" at the top of the wingwalls. This maximum displacement occurred in northwest corner of the bridge as is documented by barrier - rail misalignment (Figures 13 and 14). The bridge has concrete slope protection that slightly bulged at both abutments.

Figure 13. **54-0734** **Lavic Road OC**
 Considerable transverse movement in the northwest abutment and wingwall.

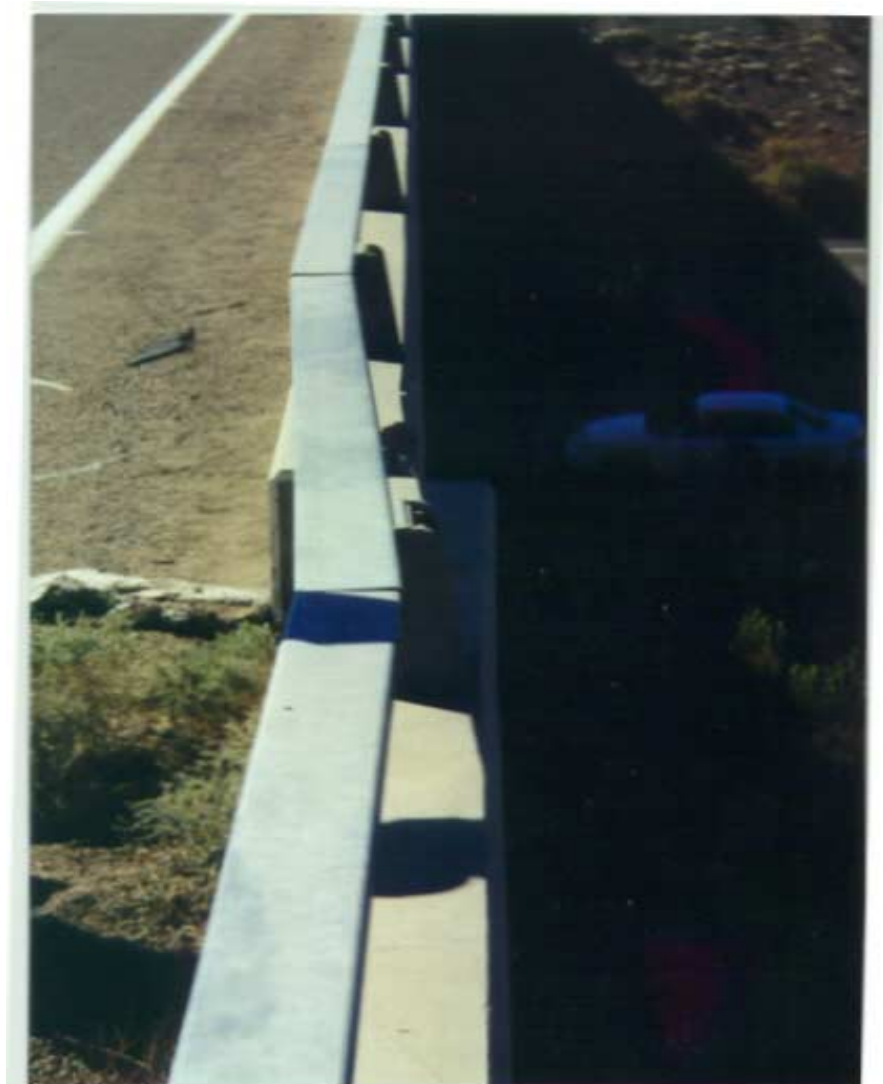
Figure 14. **54-0734** **Lavic Road OC**
 Considerable transverse movement in the northwest abutment and wingwall.

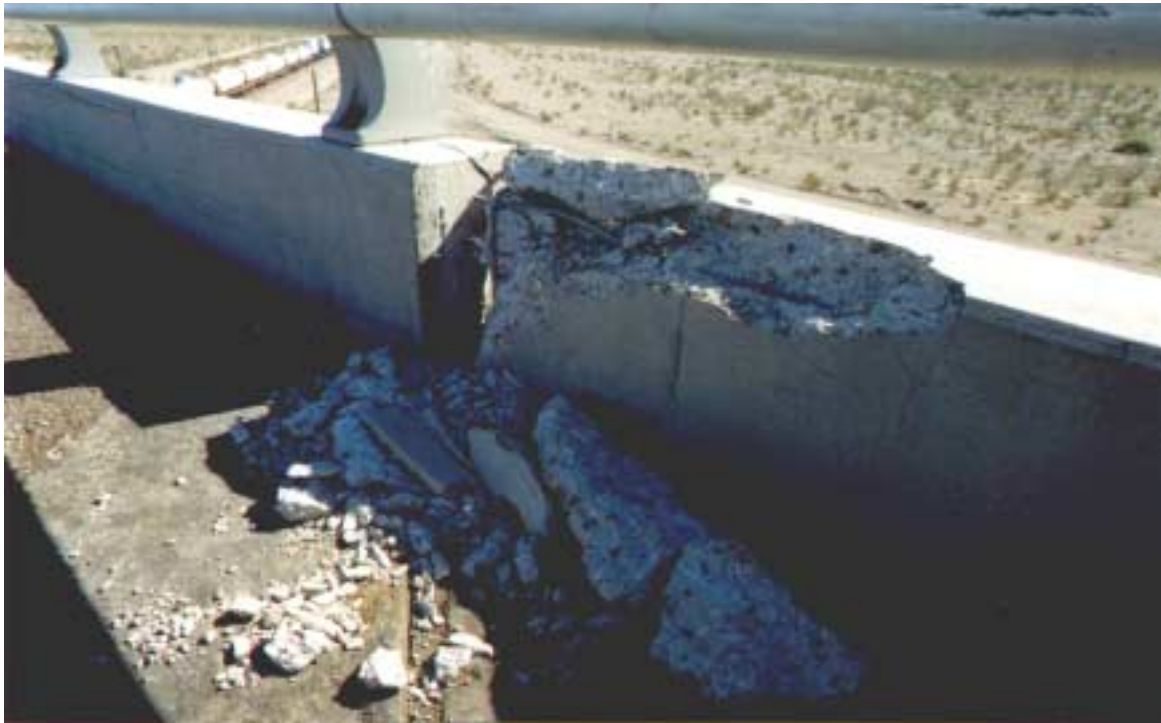
Figure 15.

When the bridges moved longitudinally, they engaged the abutment curtain walls. This resulted in shear cracks along the sides of abutments and wingwalls (Figures 17 and 18). Wingwalls and their barriers at abutment locations sustained damage due to the longitudinal and transverse movements of the bridges (Refer to Figures 15, 19 and 20).

Barrier rail damage at South Abutment.

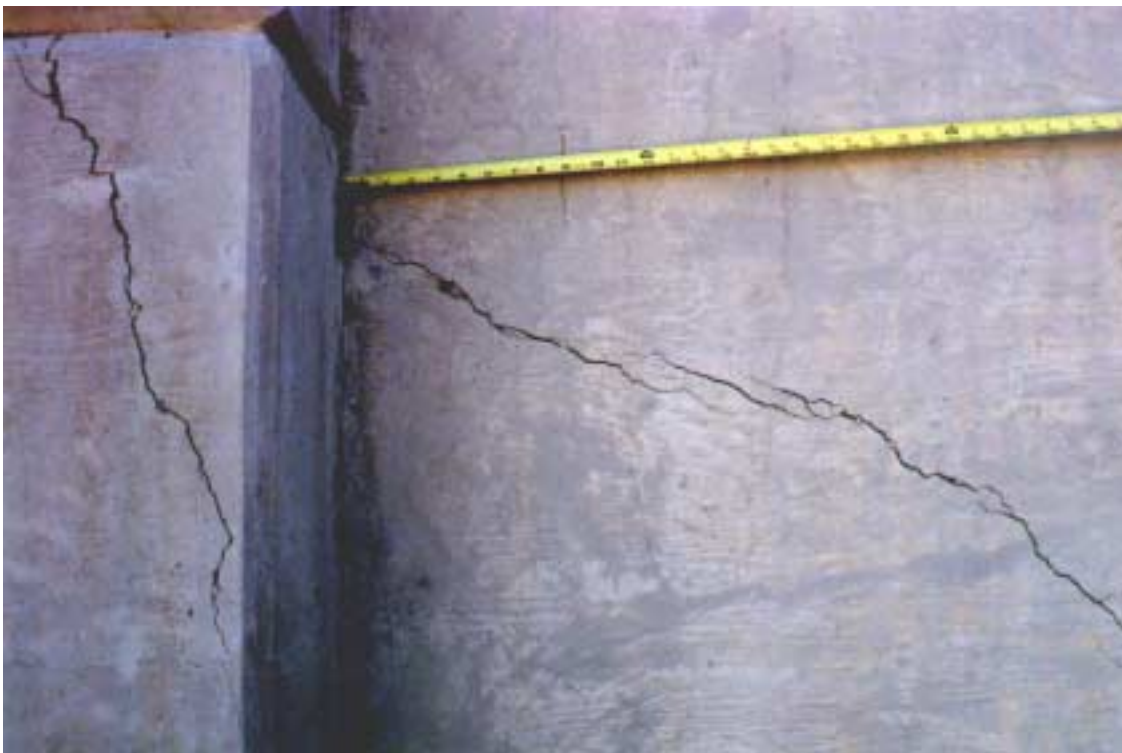
Figure 18.

Details of shear damage at west abutment due to longitudinal and transverse movements.

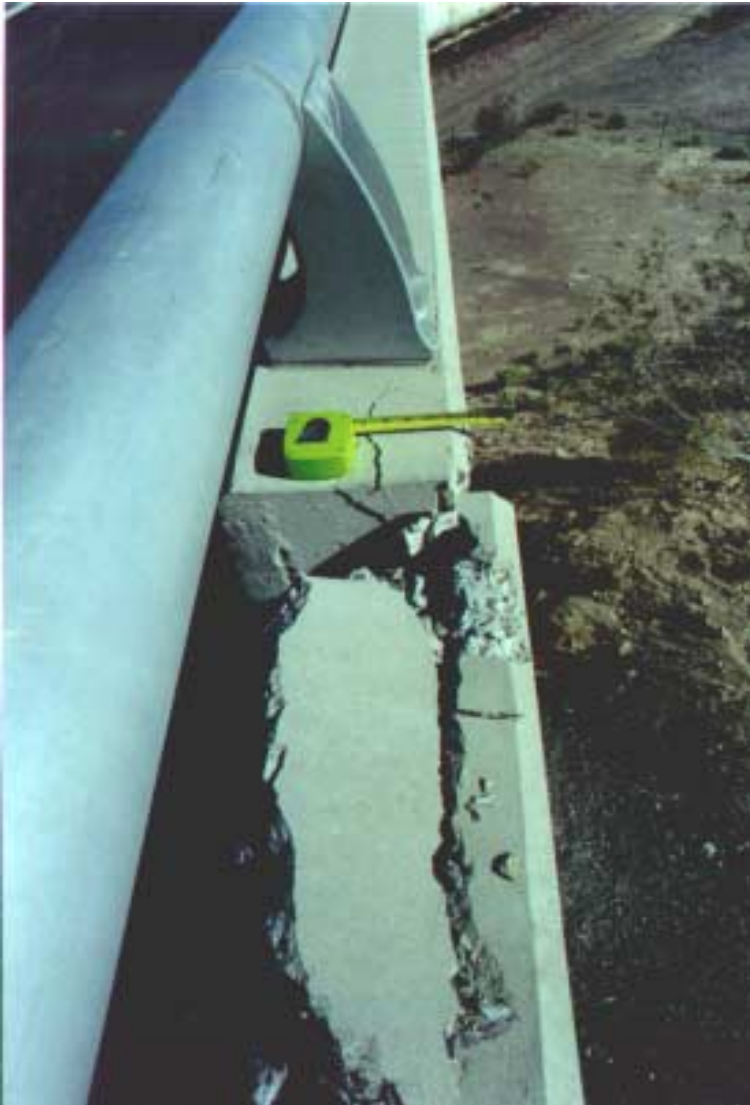
Figure 19. **54-0689 R / L** **Pisgah OH**
 Damages to barrier and wingwall due to longitudinal bridge movement.

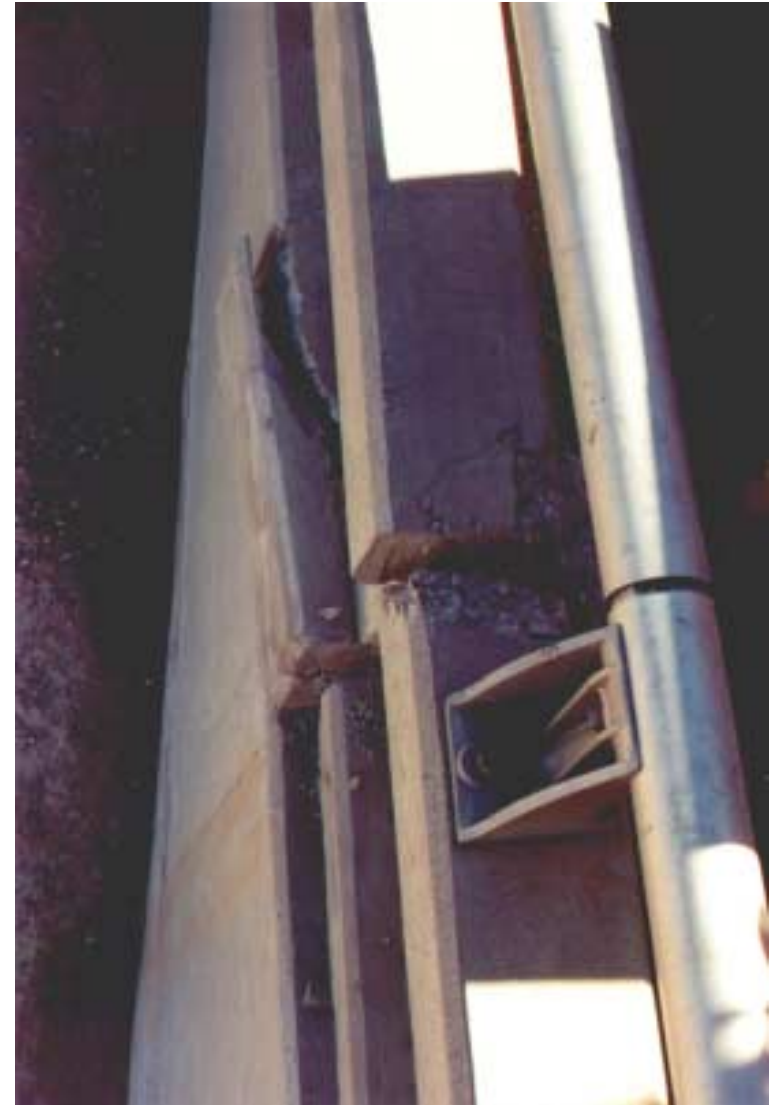
Figure 20. **54-0689 R / L** **Pisgah OH**
 Damage to barrier rail.

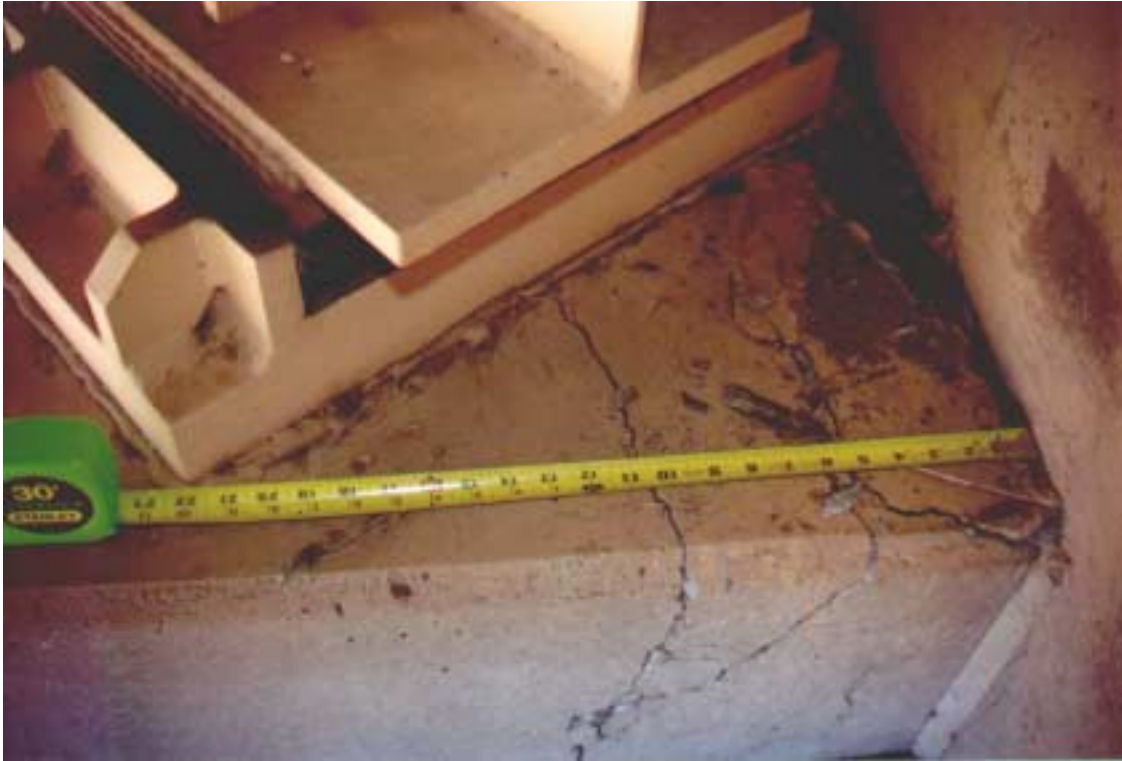
Figure 21.

There are two reasons for the cracks at steel bearing pedestals. First, some pedestals were previously cracked due to the presence of reactive aggregate in the concrete. Secondly, the previous cracks were most likely enlarged when the upper steel bearing plate engaged the bottom 'U' shaped part of the steel bearings (See Figure 22). The rubber layer between the plates served as an isolator, but was not thick enough to allow the upper plate unrestricted movement. The damage to the pedestals occurred at two out of four at each abutment. In general, bearings with smaller gaps between the bottom and top steel plates were cracked, while others with sufficient gap between the steel upper and bottom plates remained undamaged.

Steel bearing induced cracks.

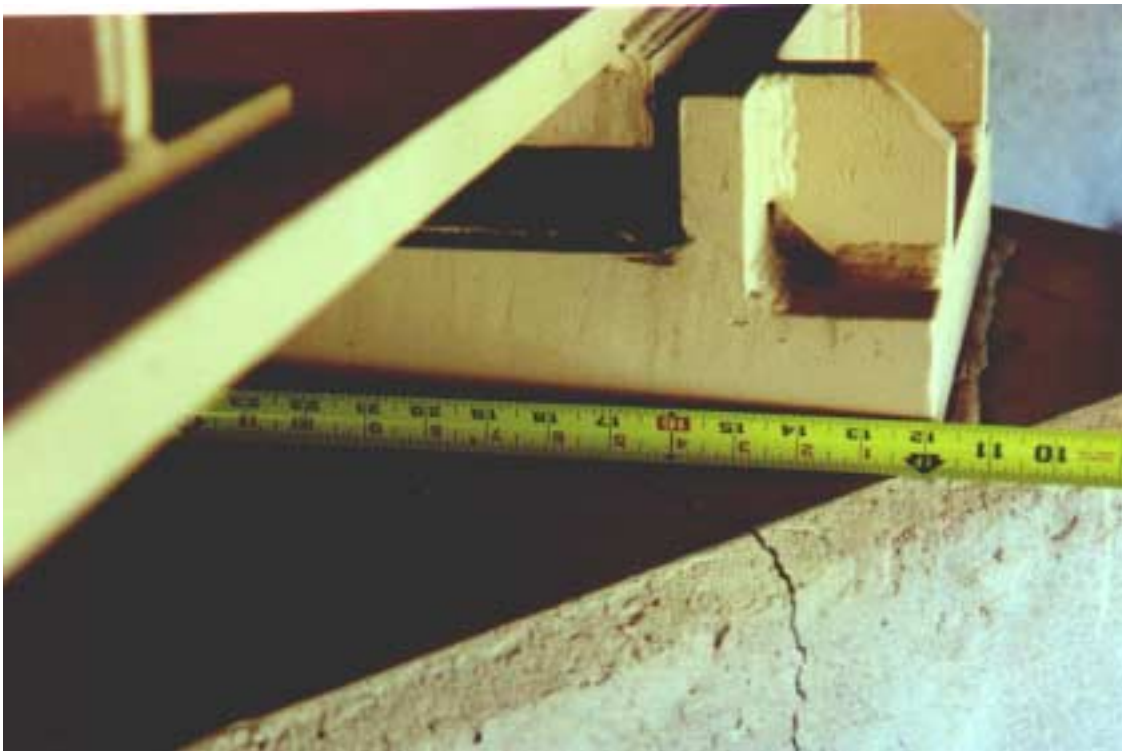
Figure 22.

Pedestal damage at west Abutment. Note small gap between top and bottom steel plates.

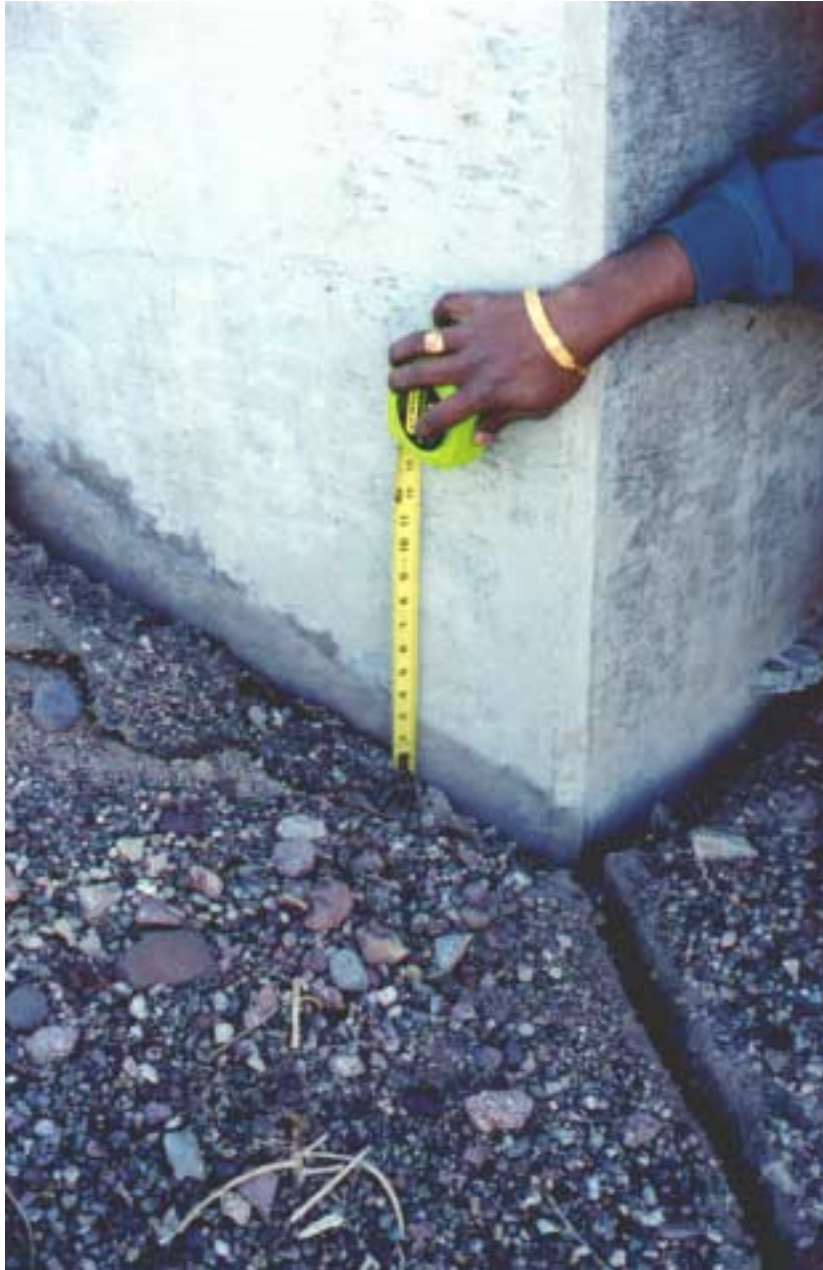
Two parallel structures are standard slab bridges on pile extensions. There was no major damage to these structures except minor concrete cracking. There was no concrete spalling. We found evidence that the structures had moved approximately three inches in the longitudinal and transverse directions (Figure 25). Embankment settlement was up to four inches. The pile extensions had moved as well, resulting in sand cones forming around the piles at the surface level. The cones extended about 24" from the face of the pile extensions (See Figures 26 and 27).

Figure 25 **54-0737 R/L** **Argos Wash Bridge**
Abutments experienced considerable movements with no damage.

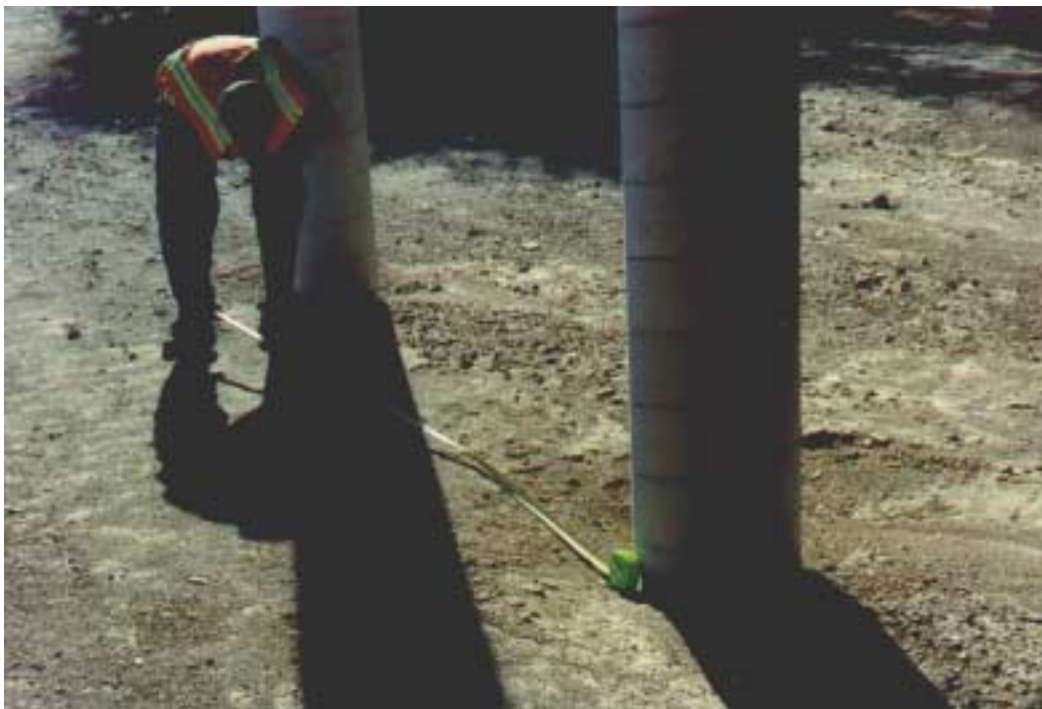
Figure 26. **54-0737 R/L** **Argos Wash Bridge**
Approximately 3" settlement of sand around some CIDH piles / pile extensions.

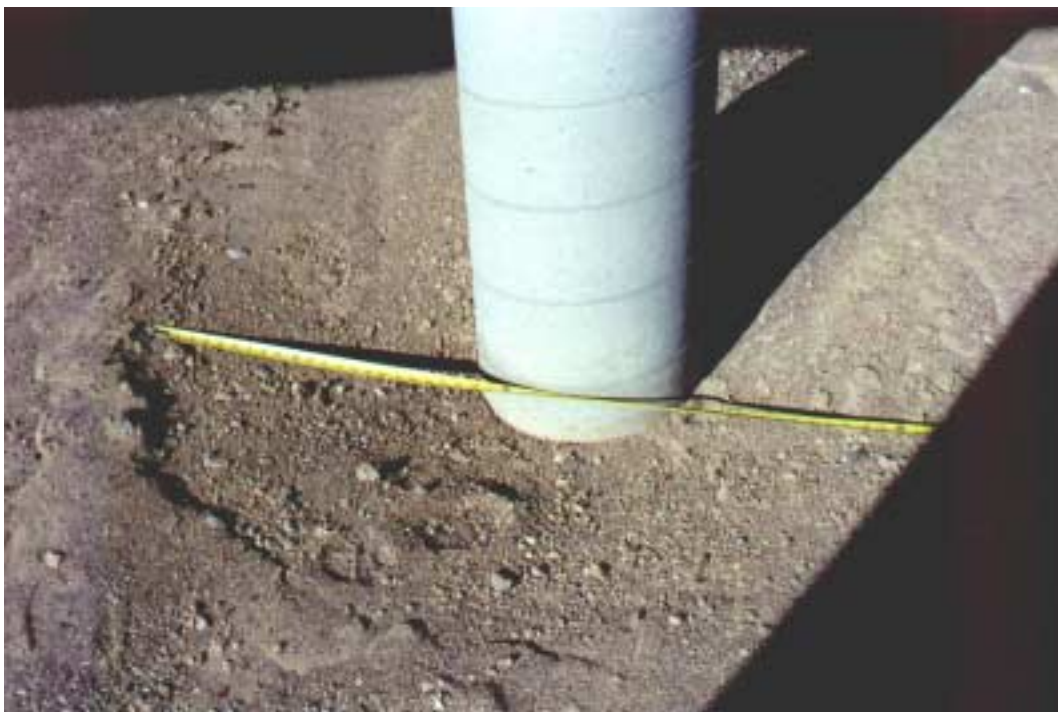
Figure 27. **54-0737 R/L** **Argos Wash Bridge**
Formation of soil cones around the pile extensions.

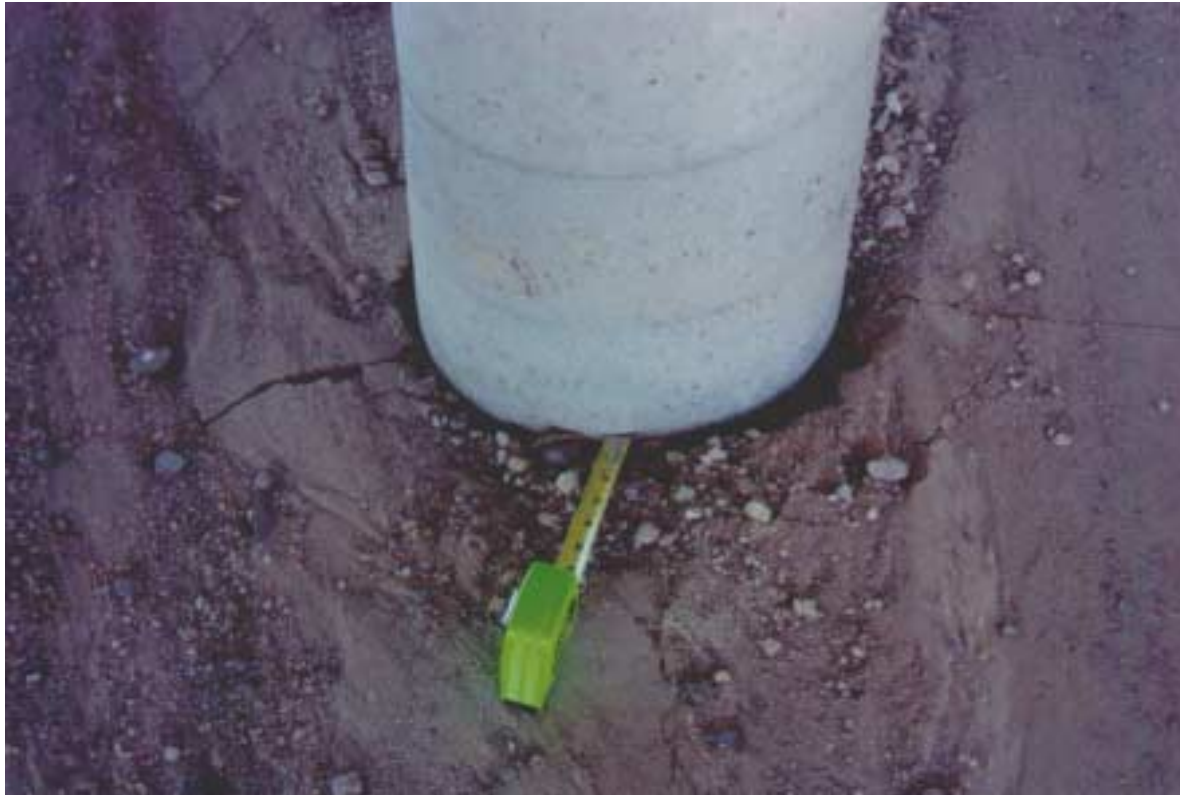
These bridges are also standard slab structures on pile extensions. The Sand Hill Wash bridges behaved similarly to the Argos Wash structures, only the described findings were smaller than in the case of the Argos Wash Bridges. It is our opinion that this was most likely due to more distance from the earthquake epicenter. The movements at the abutments were about two inches. There was no damage to these structures except minor concrete cracking. We could observe that the pile extensions had also moved in this case. However the size of cones formed in the sandy soil was smaller than in the case of Argos Wash Bridges. The cones extended only six inches from the face of the pile extensions (Figure 28).

Figure 28. **54-0736 R/L** **Sand Hill Wash Bridge**
Movement / cones in the sand at the bottom of pile extensions were smaller than at Argos Wash bridges.

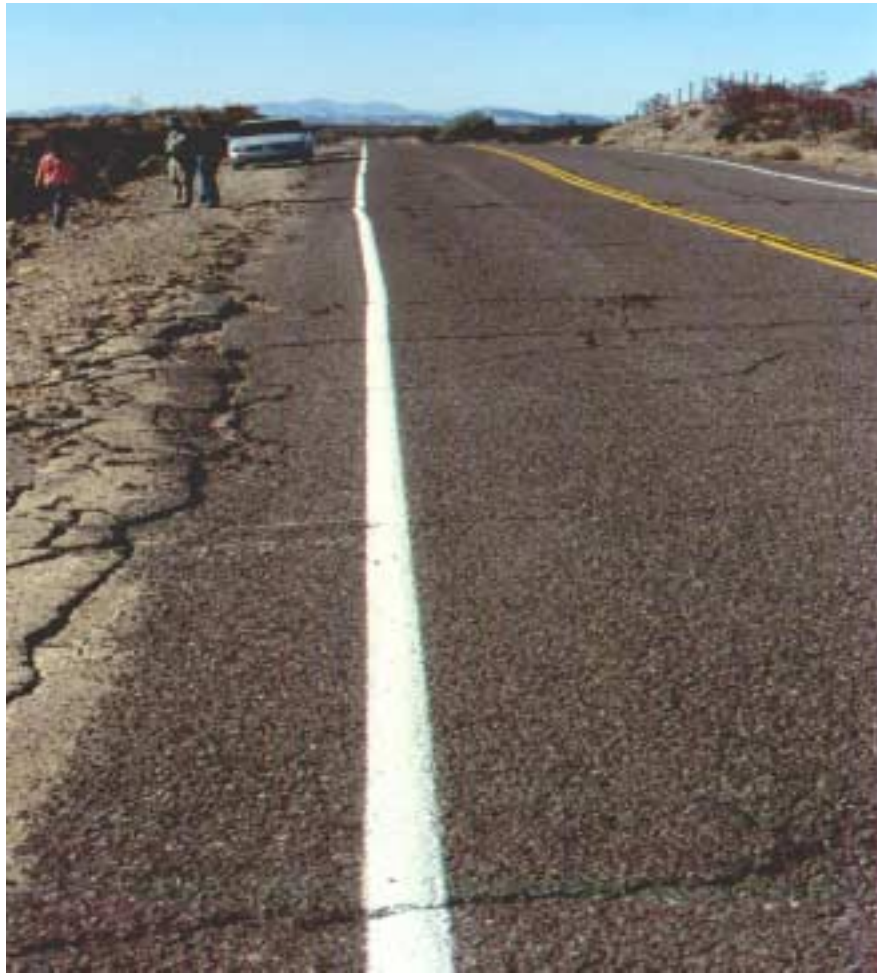
Locating the fault rupture directly on Hwy I-40 pavement was difficult. We noticed only minor damage to freeway I-40 shoulders, with no visible cracks in the pavement. We found, however, more evidence on the pavement along the historic Rt. 66. Route 66 in this location is parallel and essentially a frontage road for I-40. Distance between the two routes is approximately 100 yards. There was some damage to the pavement on Route 66 due to the surface rupture. The offsets at the shoulder lines can be seen clearly on Figures 29 and 30. It is our opinion that this type of damage has been caused by a right-lateral strike-slip fault rupture causing the road pavement to shear.

Figure 29. **Route 66**
Moderate surface rupture and ground translation along Rte. 66 approx. 100 yards South I-40 and 300 yards North from Amtrak’s derailed cars.

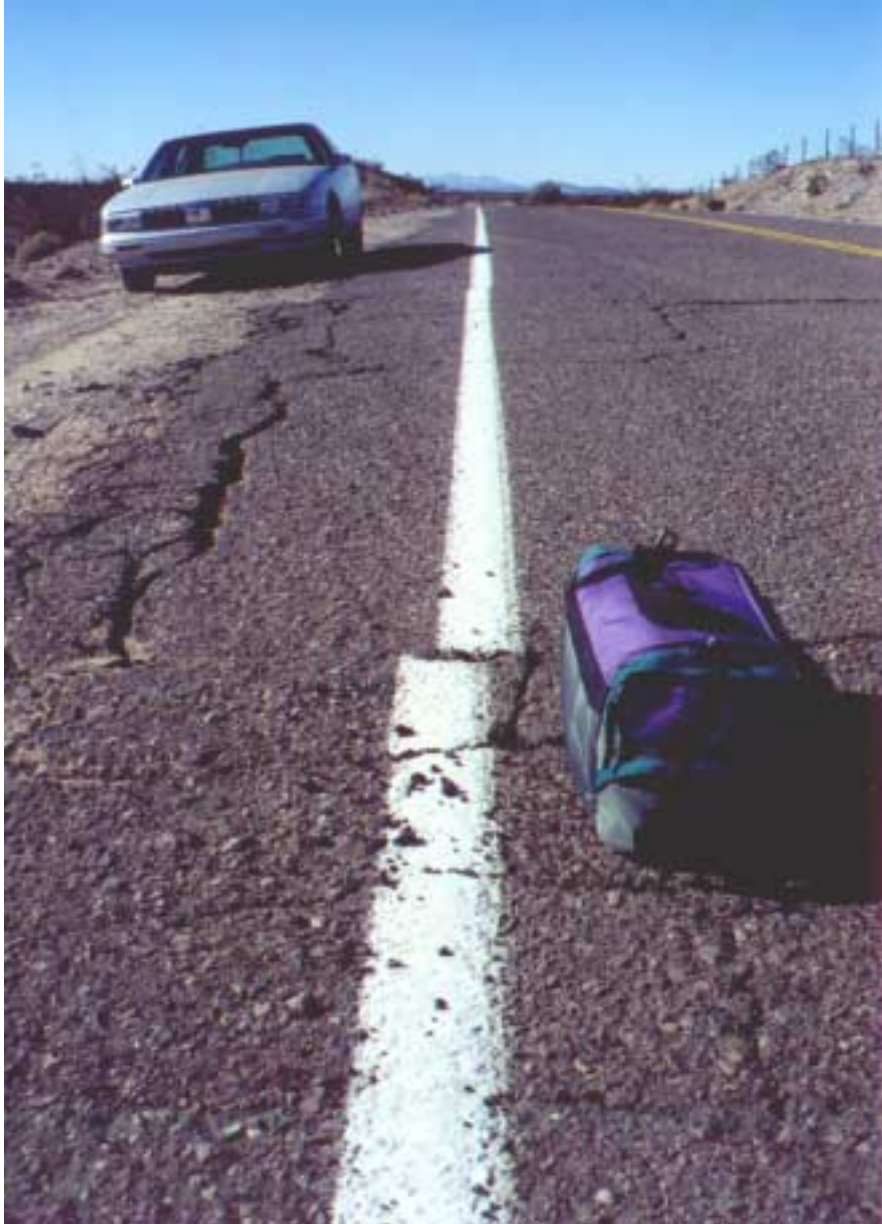
Figure 30. **Route 66**
Moderate surface rupture and ground translation along Rte. 66 approx. 100 yards south of I-40 and 300 yards north from Amtrak's derailed cars.

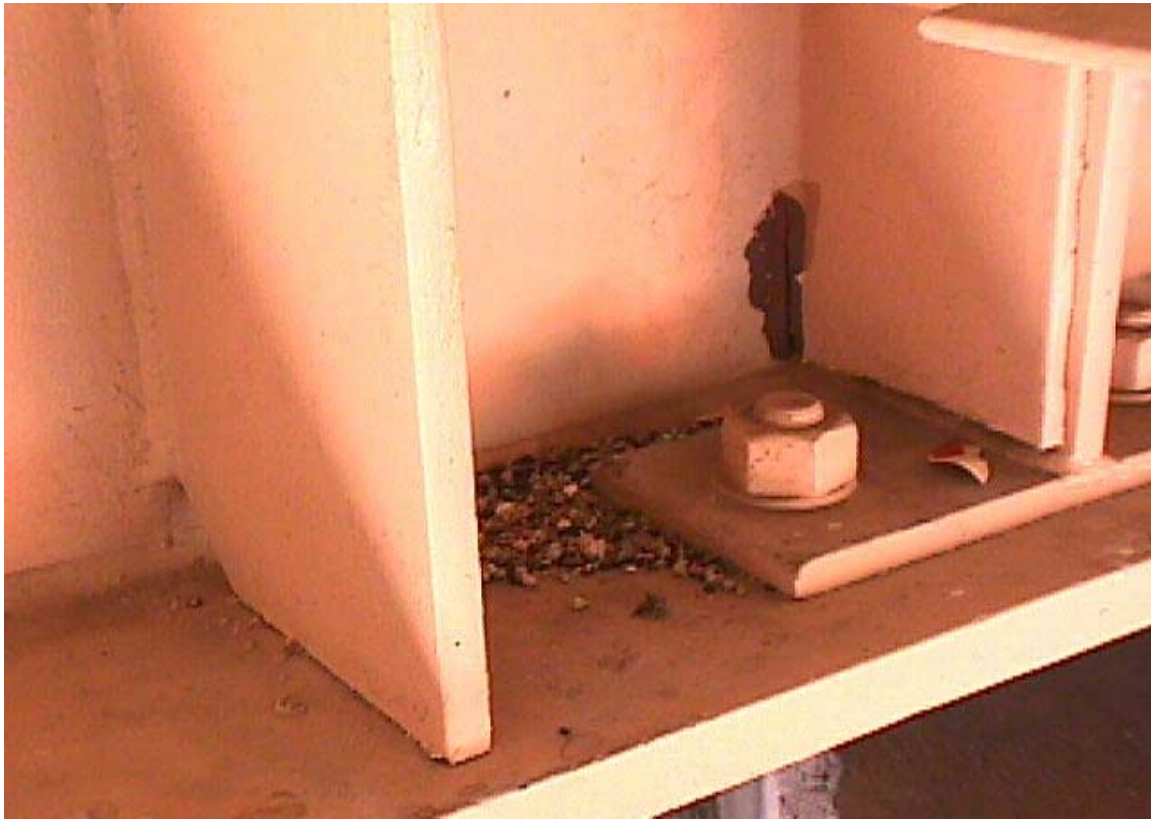
Figure 31.

The Pisgah Overhead structures has had a history of problems with weld fractures at the connections of steel girder web to vertical stiffeners (See Figure 31). PEQIT found a note beside a crack that goes back to the year 1993.

Crack in the girder web - vertical stiffener connection near West abutment of the bridge.

The reason for these defects could be the use of staggered cross-bracing that develops high stresses in this type of connection. Plans were drawn in 1991 to strengthen both bridges and to stop the spread of fractures on the girders (Figure 32). However, the problem continued and was exacerbated by the recent earthquake.

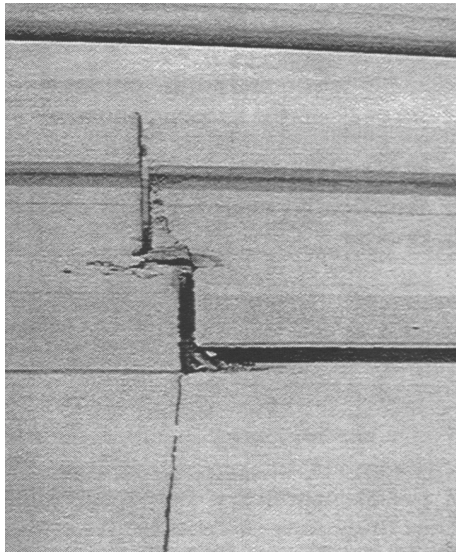
The PEQIT team encountered one additional problem with investigating bridge damage in a highly seismic area such as the Mojave Desert. They realized that sometimes it is difficult to identify damage from the most recent earthquake or from a previous one. Team members had to carefully look for rust or other signs of aging to ensure they were not looking at damage from the 1992 Landers, 1992 Joshua Tree, or even from the 1986 North Palm Springs earthquake. For instance, Figure 33 shows abutment damage at Pisgah OH during the 1992 Landers earthquake. Figure 34, in our opinion, depicts the same location photographed after the 1999 Hector Mine earthquake.

Figure 33. Abutment Damage at Pisgah OH after 1992 Landers Earthquake.

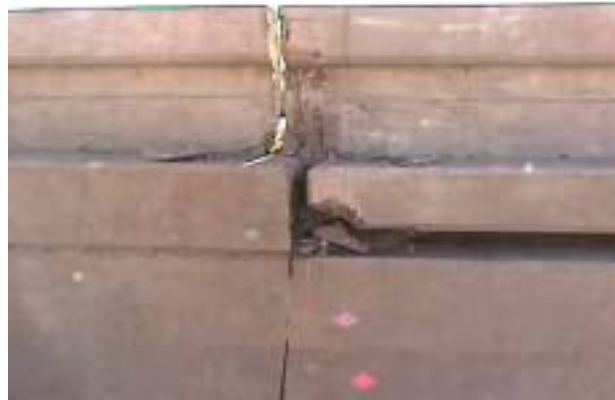
Figure 34. Abutment Damage at Pisgah OH Photographed after the 1999 Hector Mine Earthquake.
